Conesus Highway Report to the Town Board  
September 8, 2010

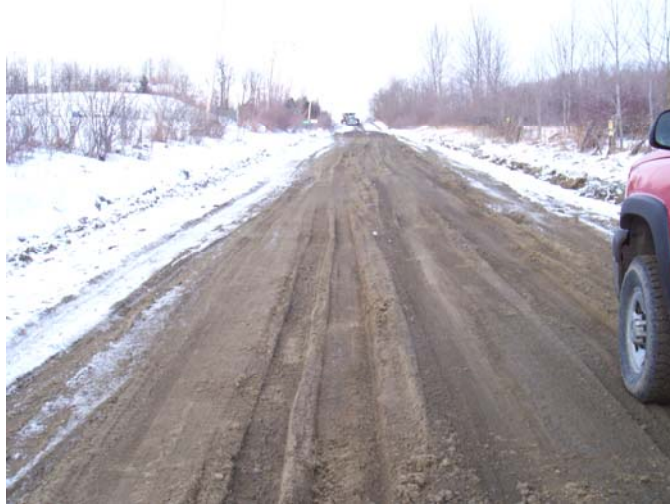
In order to understand the scope of the work completed on Bishop Road over the past two years – this was taken in late February 2009. To put it mildly, the road was in terrible condition.

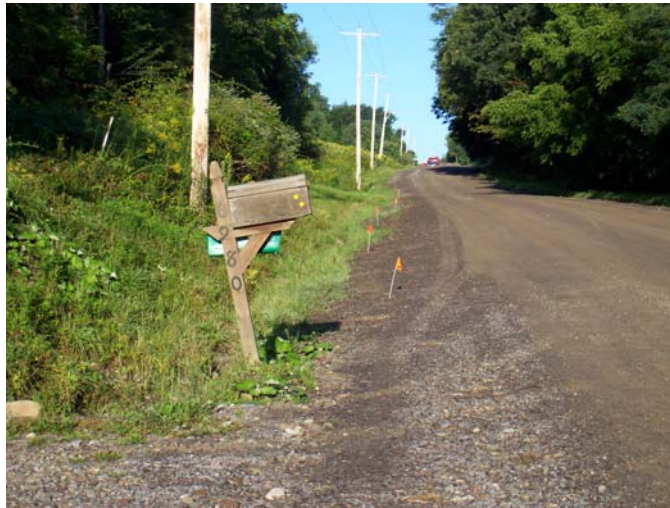
The road was gravel/dirt and the grade is  $\geq 3\%$  and the hill is over 8,000 ft in length. These factors resulted in the issues with ditch as well as road bed erosion. The erosion was so bad that in the spring of each year the underground telephone lines were exposed and had to be recovered. The lines are where the red flags are located.

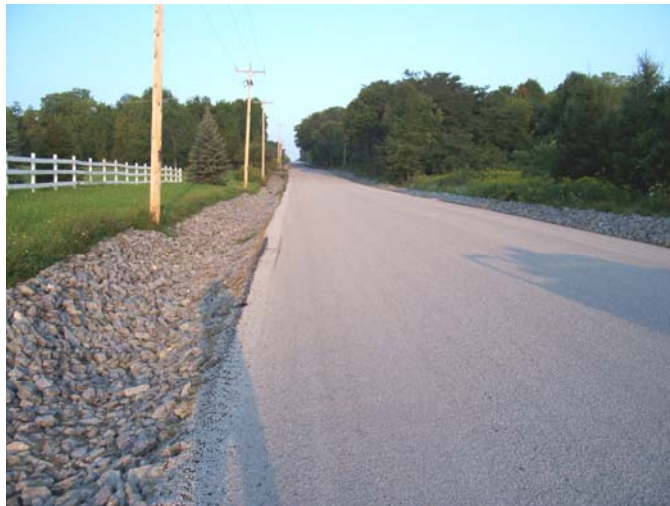
The finished product in August 2010. This area of Bishop Road was more expensive to rebuild than normal due to the additional gravel and the stone needed to armor the ditches to control erosion. Bishop Road is within both the Conesus and Hemlock Lake Watersheds.
